## **IDENTIFICATION AND PREVENTION OF STRUCTURAL VIBRATIONS OF HIGH PERFORMANCE MACHINES**

**Abstract.** *The High Performance Machines are prone to presence of different types of dynamic loads, which can lead to vibrations of the entire structures or their local parts. In the paper examples of identifications of vibration problems of High Performance Machines are shown. Investigations base on experimental methods and numerical simulations. In addition, the methods of preventing vibration of the investigated objects such as bucket wheel excavators, roller mills, crushers load carrying structures are presented.*

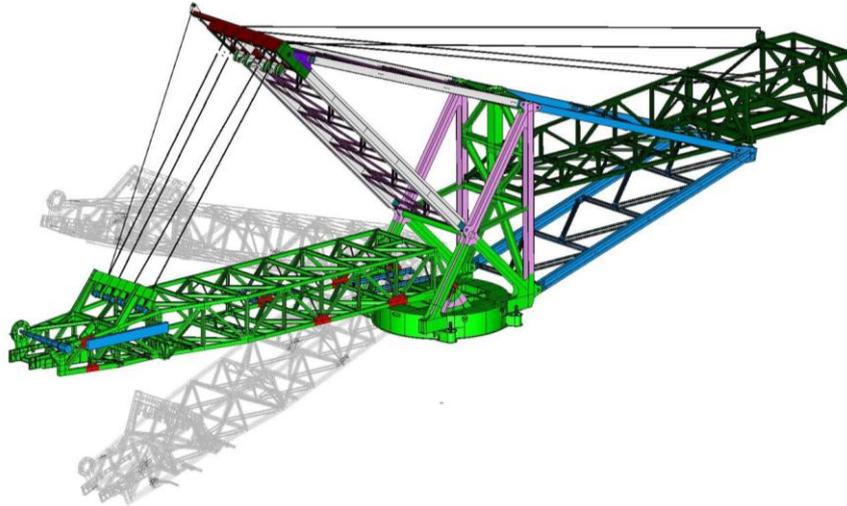
In purpose of dynamic characteristics identification, complete finite element model of the slew able superstructure was built in the CAE system (Figure 1.).

Figure 1: The numerical model Slew-able superstructure of the KWK 1500 excavator.

Structural members were substituted by the beam and shell elements. Detailed representation of the superstructure was required for popper simulations. The subassemblies of the lower part like undercarriage were replaced by the deformable elastic elements of corresponding stiffness. Simulations of the structure were performed in purpose to establish global and local natural frequencies. The calculated data were analysed then in consideration of excitation frequency which is related to design of excavating unit (bucket wheel and the drive).

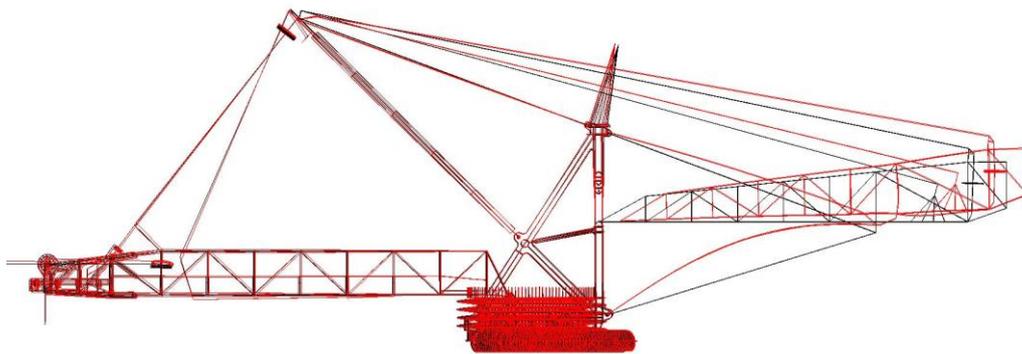
The performed simulations pointed out that the second harmonic of the excitation frequency is close the range of the 6<sup>th</sup> structural mode of the excavator and equals 2.03Hz. The deflection shape (Figure 2) creates large horizontal displacement of counterweight boom and vertical displacement of its supporting structure.

Figure 2: The 6<sup>th</sup> normal mode of the excavator.

The deflection shape is directly related to the support of the counterweight boom of the machine. The front mounting point of the boom is flexible and creates possibility of large displacement. The analysed system of the counterweight support is shown in Figure 3.

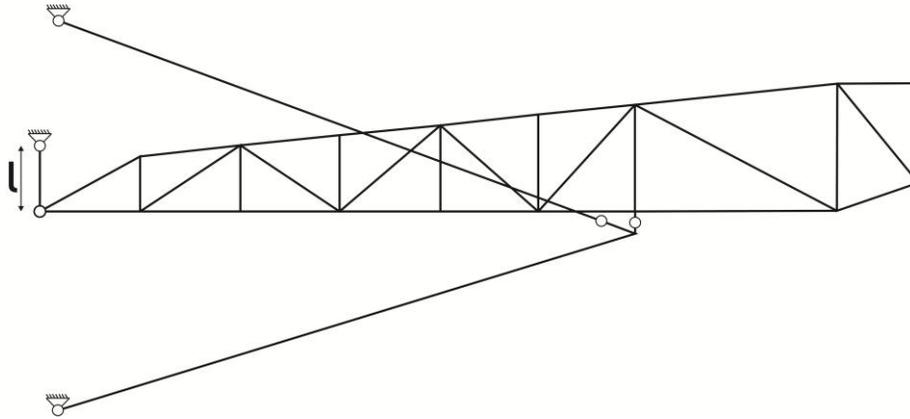
Figure 3: The sketch of the supporting system of the counterweight support in preliminary version.

In such design the excavator will operate with increased vibration amplitudes of the counterweight boom. With high probability, this will lead to fatigue damage of structure members in longer time period. Increased vibration amplitude is also unfavourable for the operating staff of the machine. Considering above, it was required to provide corrective actions to prevent possible problems. Many different support types and its influence on the structure dynamics were considered during numerical analyses. The new solution of the counterweight boom support was designed. The flexible front support was replaced with a fix joint while the rear part of the counterweight boom was supported on the tie, which compensates horizontal displacements. The sketch of the final support solution is shown in Figure 4. With this solution the unfavorable mode observed in the preliminary design does not occur any more.

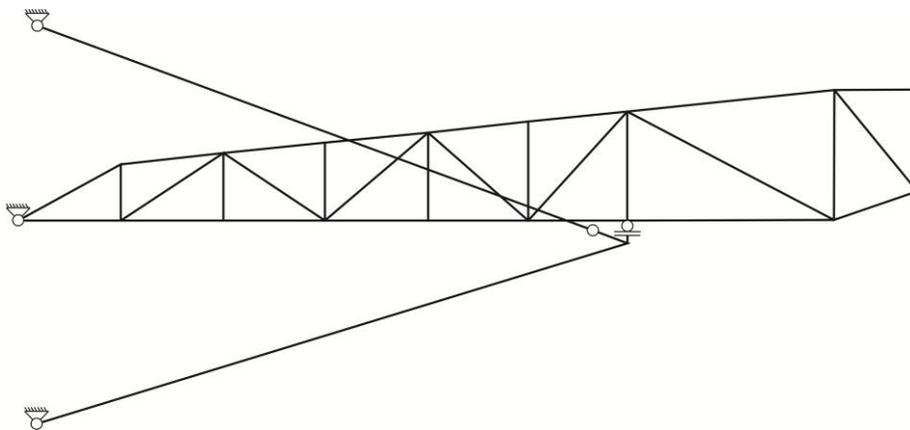
Figure 4: The sketch of the final design of the counterweight boom supporting system.

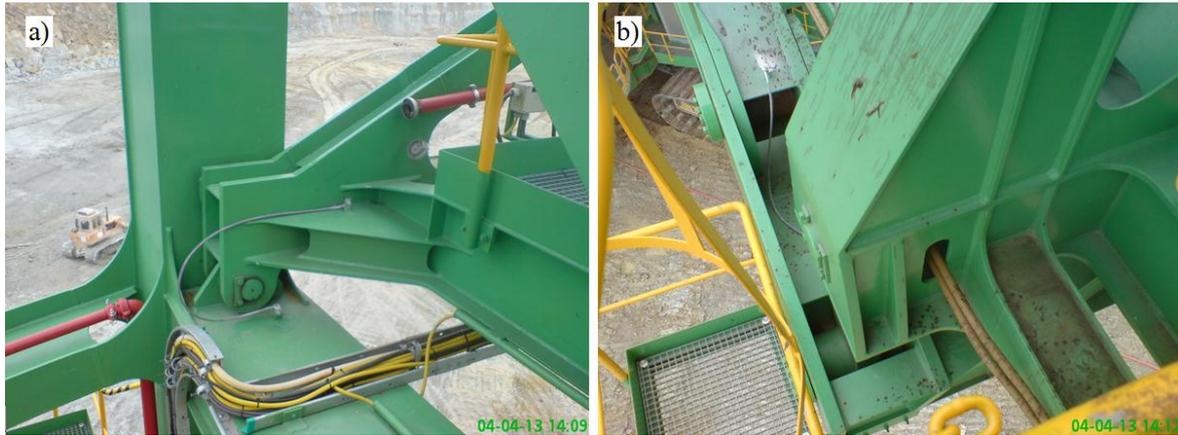
The new design of the counterweight support was successfully incorporated in the real structure (Figure 5) and tested. There are no resonance vibrations present during normal operation of the excavator. In this case the designing problem was found and corrected at the designing stage.

Figure 5: The final design of the counterweight boom supporting system: front a); rear support b).

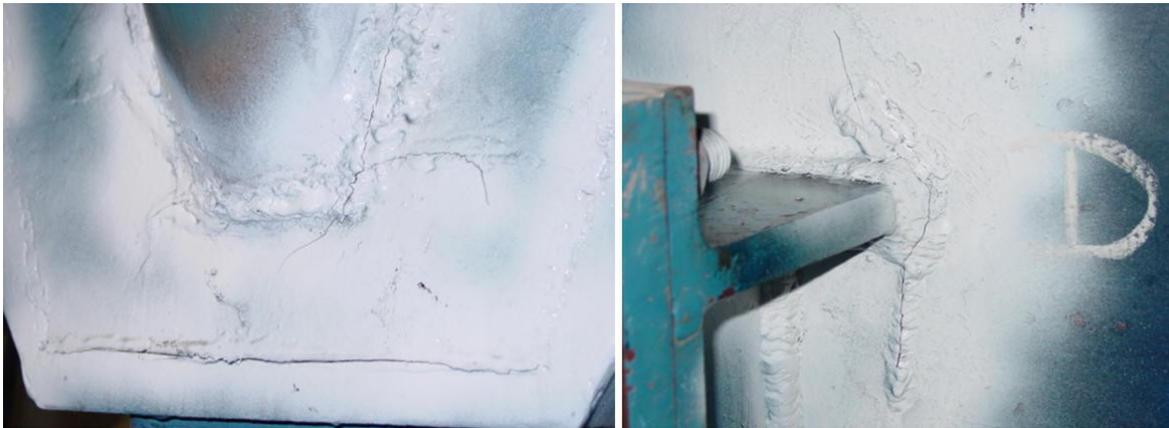
The research object was a roller mill with the stable race for a limestone milling. After few years of operation the progressive degradation of supporting structure and the foundation of the mill was observed. The example of cracks in the steel construction is shown in Figure 6.

Figure 6: Example of cracks of the steel structure of the roller mill.

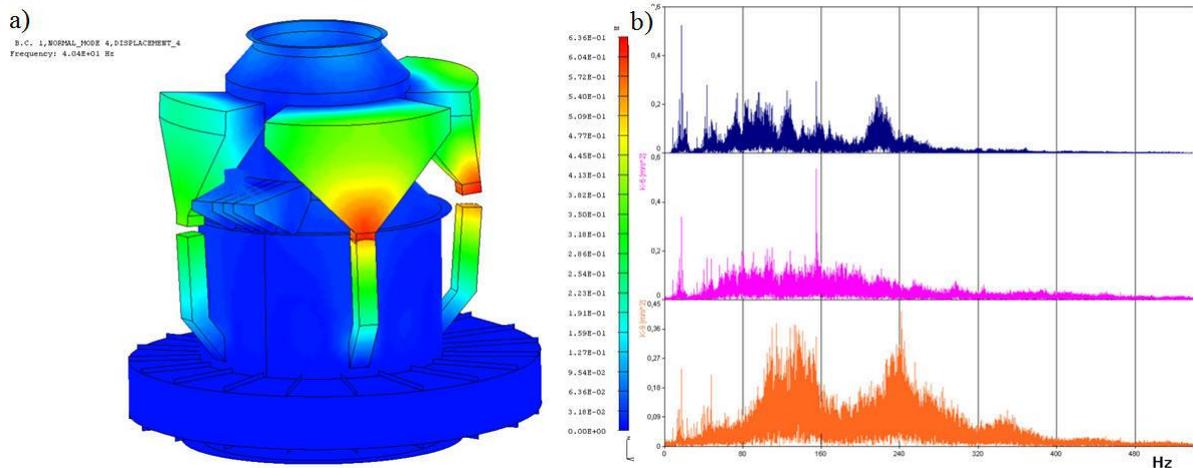
In order to define a modal characteristic of research object the numerical simulations with the use of FEM and experimental tests were conducted. The numerical calculations results gave information about the frequencies and shapes of free vibrations modes related mostly with the vibrations of the air-ducts and the return passages of the separator. The frequencies are in the range between 30Hz and 50Hz. Figure 7a shows example of such vibrations.

In order to define a mill vibration spectrum during the operation the acceleration measurements in the characteristic points of the structure were conducted. The example graphs of the vibration amplitudes in the frequency domain of three chosen measurement points are presented in Figure 7b. Recorded vibrations enable to define the forms and periodicities of mill vibrations during the starting and steady state conditions. The maximal vibrations occurred during the start-up of the mill (unsteady state). These are radial and vertical vibrations in the

frequency range between 95Hz and 142Hz. Moreover in the return passages the significant vibrations of frequency 43Hz and 49Hz were observed. These periodicities cover with free vibration frequencies received from the numerical calculations.

Figure 7: Free vibration mode of the mill structure a); Vibration amplitudes in the frequency domain of three chosen measurement points b).

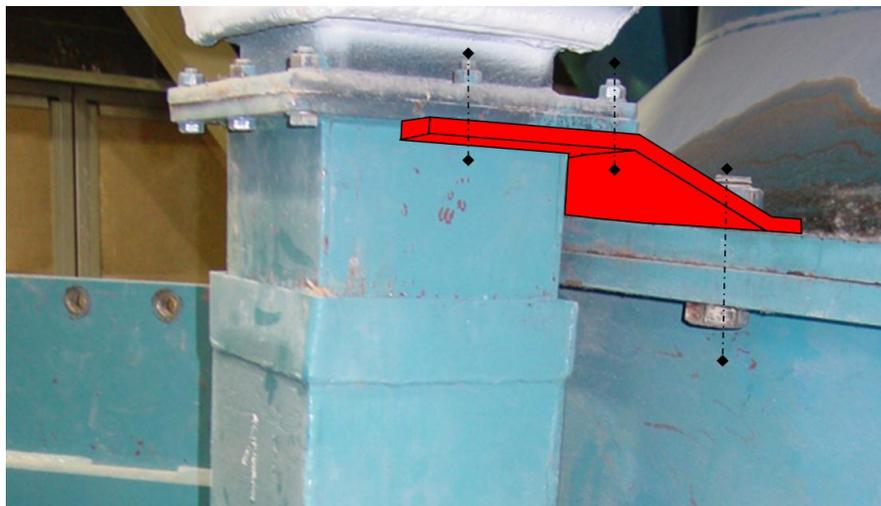
The research results showed an occurrence of significant vibrations of the object and the resonance effect of external elements of mill such as separators and air channels. In order to prevent such quick degradation, additional reinforcements were added to increase stiffness of these elements. Example view of such reinforcement is shown in figure 8.

Figure 8: Reinforcement of separator channel.

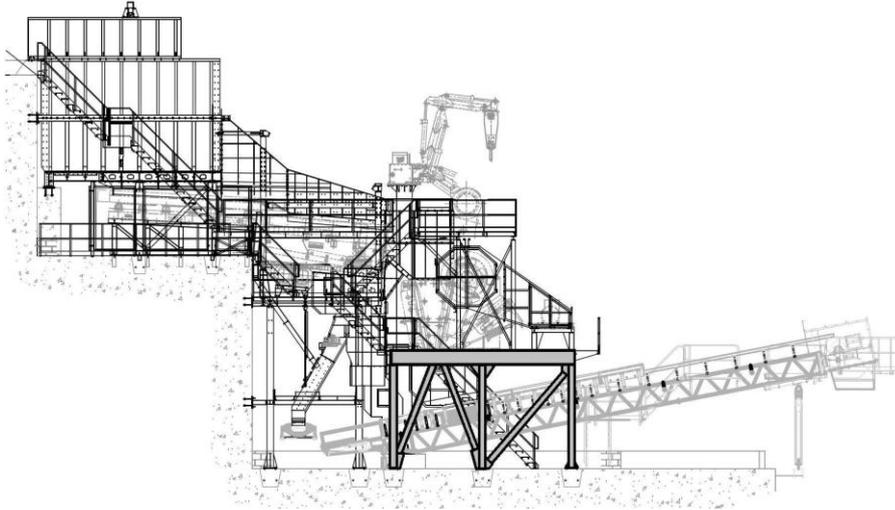
The crushing station consists of typical equipment such as chute, conveyors system, hammer and jaw crusher, which is supported on the steel frame anchored to the concrete foundations. The view on crushing station is shown in Figure 9.

Figure 9: Jaw crusher layout

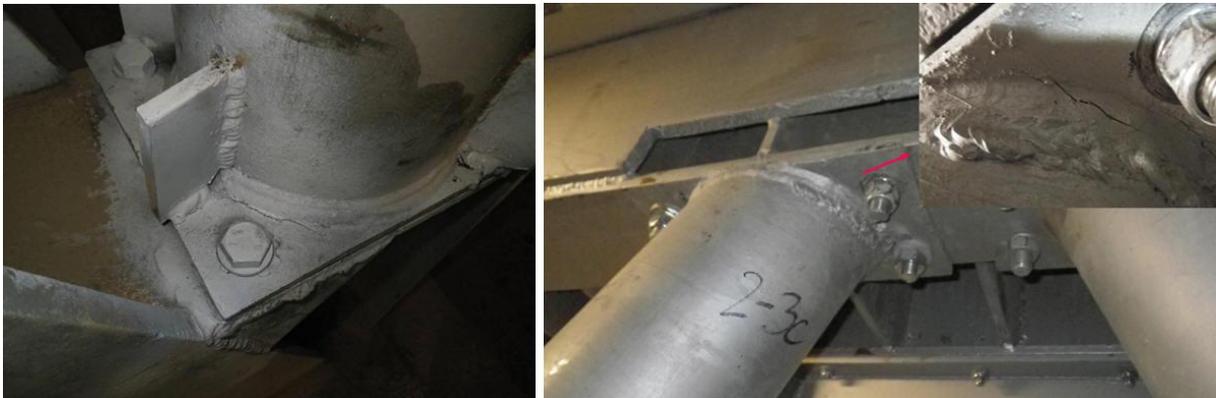
In a short time of operation of the new crusher, a lot of fatigue cracks and bolts damages of the crusher supporting structure were observed. Exemplary view of cracks of vertical bracings is shown in Figure 10. Numerical methods and experimental tests were used to find out the reasons of such problems and to solve it.

Figure 10: Jaw crusher layout.

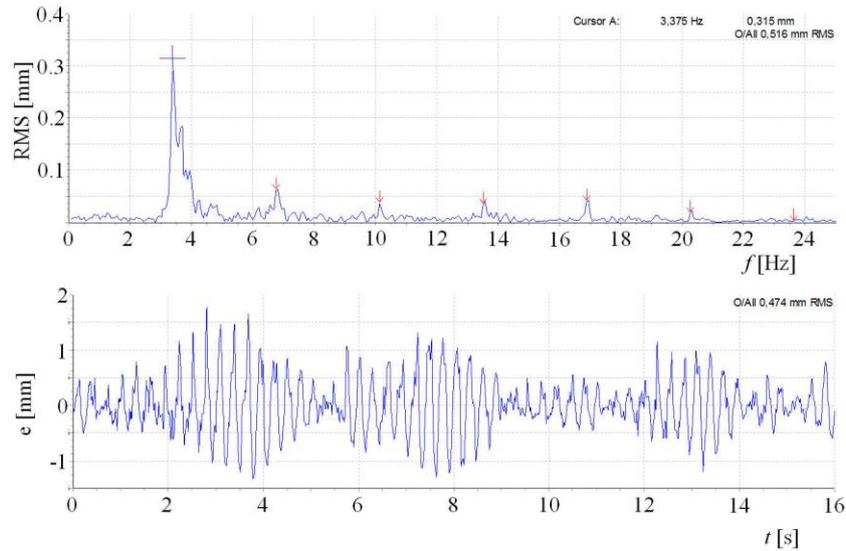
The first part of investigations was aimed to measure dynamic behaviour of the structure and estimate dynamic loads causing fractures. Measurements of displacements vibrations of the support frame were done with the use of scanning laser and standard vibrometers. As a results of such measurements, vibrations spectrum and time signals were obtained. Example graph of measurements results are shown in figure 11. It was found that transversal vibrations of the structure are caused by resonance effects. The frequency of resonance vibrations was matching with excitation frequency:  $f_{ex} = 3.33$  Hz. It can be also observed on the time signal of vibrations where characteristic beat effect is present.

Figure 11: The time and spectrum trace with visible resonance effect - transverse displacement.

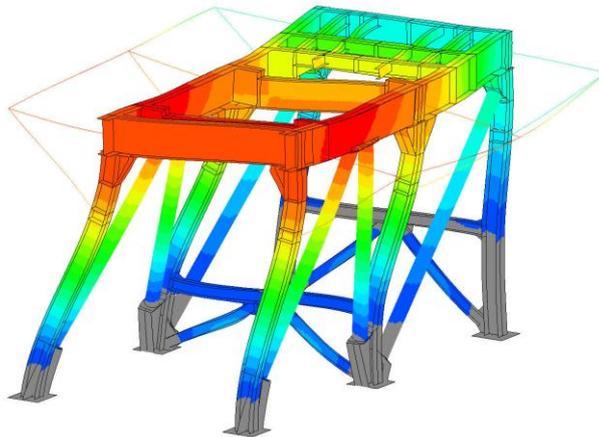
Calculations of free vibrations frequencies and modes confirmed presence of resonance in operation of the crusher. Figure 12 presents deformation plot of the first mode, which is responsible of resonance vibrations. Direction of vibrations is in line with measured on site and frequency is close to excitation load, which equals:

$$f_{\text{ex}} = 3.33 \text{ Hz} \sim f_1 = 3.39 \text{ Hz}$$

Figure 12: Natural frequency mode shape of the crusher supporting structure – mode 1.

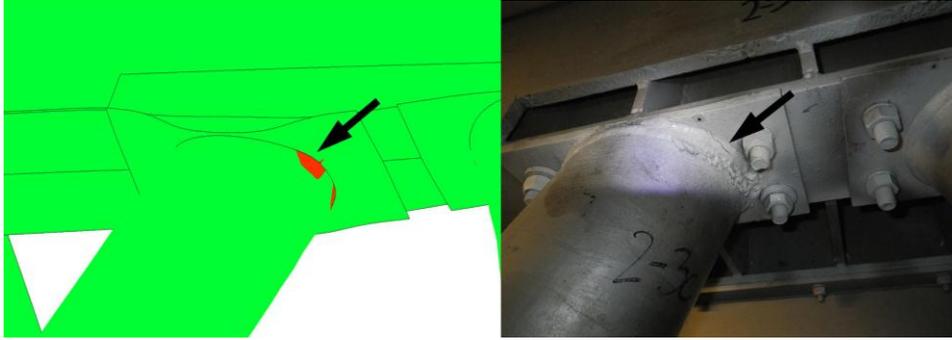
Results of fatigue calculations confirmed that areas of cracks present on the structure are overstressed and do not have proper fatigue resistance. It was found that there is 100% confirmation of the cracks locations on the real structure and in numerical model (exemplary view shown in Figure 13, red colour indicates fatigue overstressed areas).

Figure 13: Example of comparison of fatigue crack location in the numerical model and existing structure.

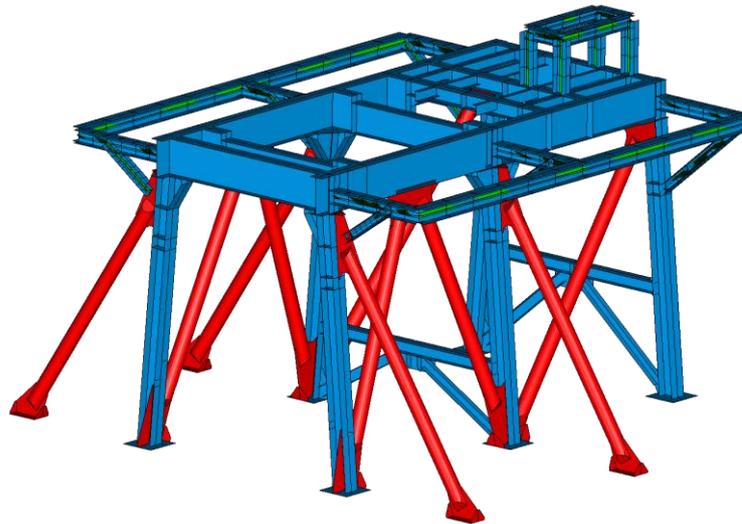
Taking into account results of experimental and numerical investigations modifications of the supporting structure were designed. It was decided to provide additional transverse stiffeners and to cut out all weak joints to replace them with new redesigned one. Special care was paid to the joints design to assure proper fatigue resistance. Figure 14 presents new design of the crusher supporting structure.

Figure 14: New design of the crusher supporting structure.

At the final stage of investigations the measurements of the dynamical behaviour of the modified structure were done. The tests were performed at the same way as tests on the original structure. Vibrations spectrum and time traces confirmed that there are no resonance vibrations present in the time trace of measured signals. The RMS value of vibrations is 400% lower in comparison to the vibrations of the original structure.

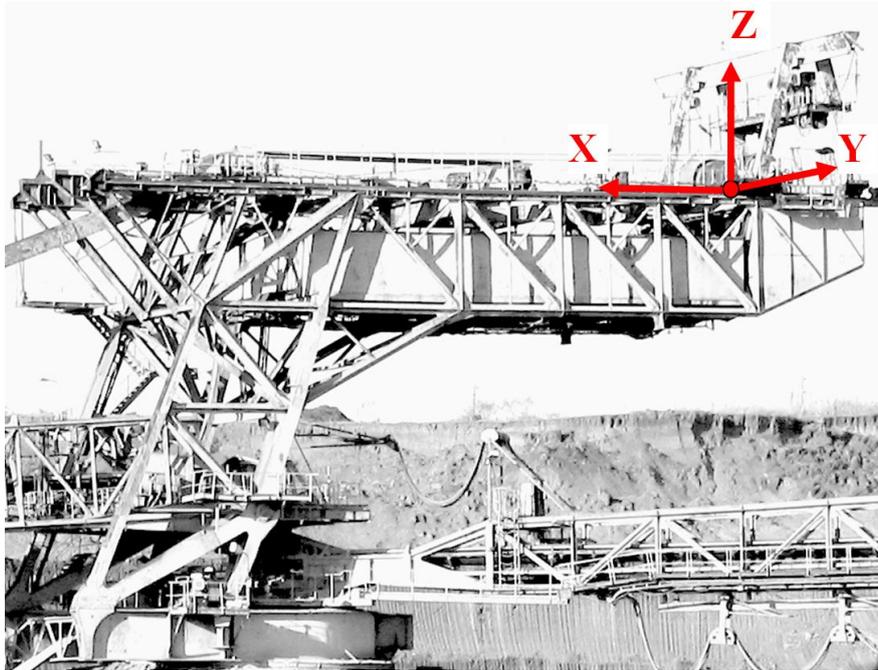
the measuring system was installed on the counterweight boom of the excavator (Figure 15). The system is to measure accelerations in three orthogonal directions.

Figure 15: Location of measuring point and directions of measured value (acceleration).

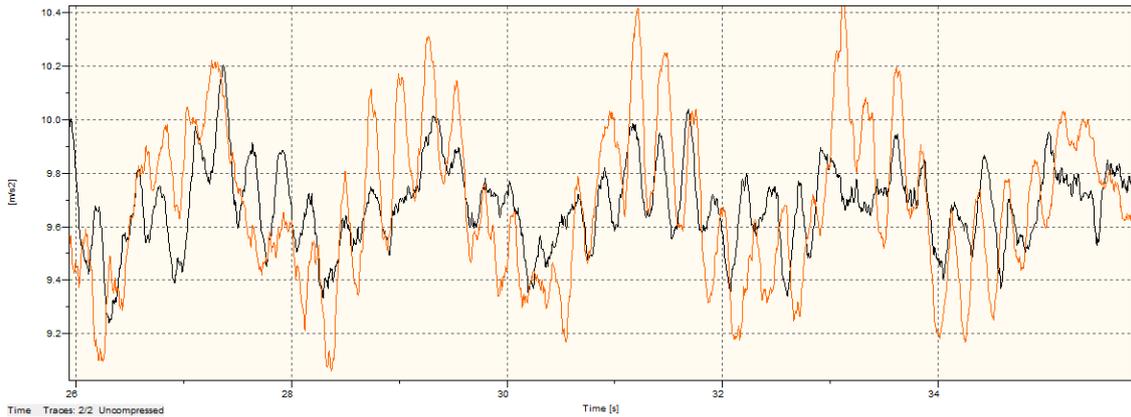
The maximum  $\psi$  coefficients for vertical (Z) the most significant direction are presented in table 1. In the table the  $\psi$  coefficients for comparable signals are presented as well. The time signals for both conditions are presented in figure 16.

Figure 16: Comparison of accelerations [ $\text{m/s}^2$ ] in Z direction: black colour-with additional counterweight; red colour-without additional counterweight.

As conditions of tests were similar for both series (cutting depth, slewing speed, number of buckets discharges, terrace level) comparison of results provides conclusion that machine equipped with additional counterweight indicates significantly lower level of vibrations than machine in original condition. The vibrations levels are within standards requirements (TGL 13472).
